Manhole Inspection Summary

Manhole # S21C1_017MH

Insp Date: **5/19/08 3:01 PM**

Location Address: **2318 winder st**

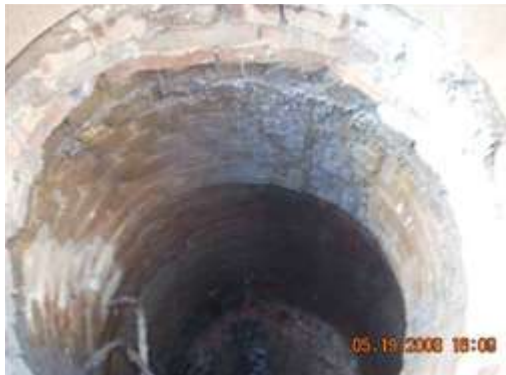
Defect 3

Infiltration: ☐ None ☐ Joint ☐ Cracks ☐ Mortar ☐ Roots ☒ **Wall**

infiltration @ corbel wall

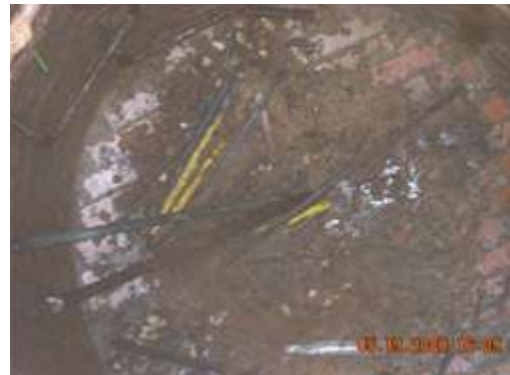
Defect 2

Condition: ☐ Sound ☐ Cracked ☐ Root Intrusion ☐ Deteriorated ☐ Leaks ☒ **Debris**

debris in terminal channel

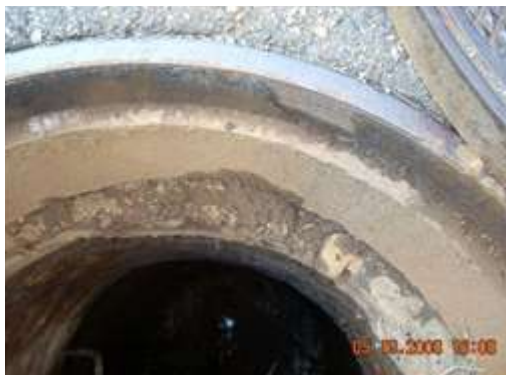
Defect 1

Offset: **2** (in.)

☒ **Leaks**

frame leaks and frame offset

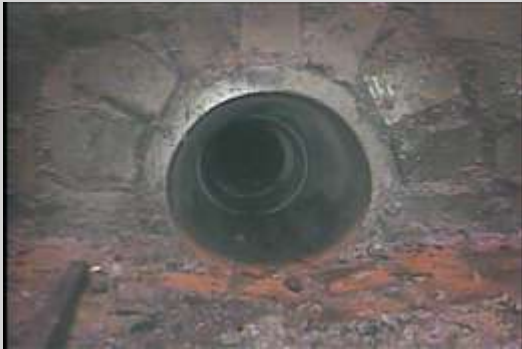
12 O'Clock Outflow

8 in. Circular Gravity Sewer
Pipe Out @ 12 O'Clock

Infiltration: **None** Pipe Seal Cond: **Sound**
